## Investigation into the fire in the Heinenoordtunnel on 21 May 2014

Report no.	2015-Efectis-R000143
Sponsor	Efectis Nederland BV
Author(s)	M.P. de Feijter B.Be. Ir. R.J.M. van Mierlo M.Sc.
Project number	2014105/111
Date of issue	February 2015
Number of pages	16

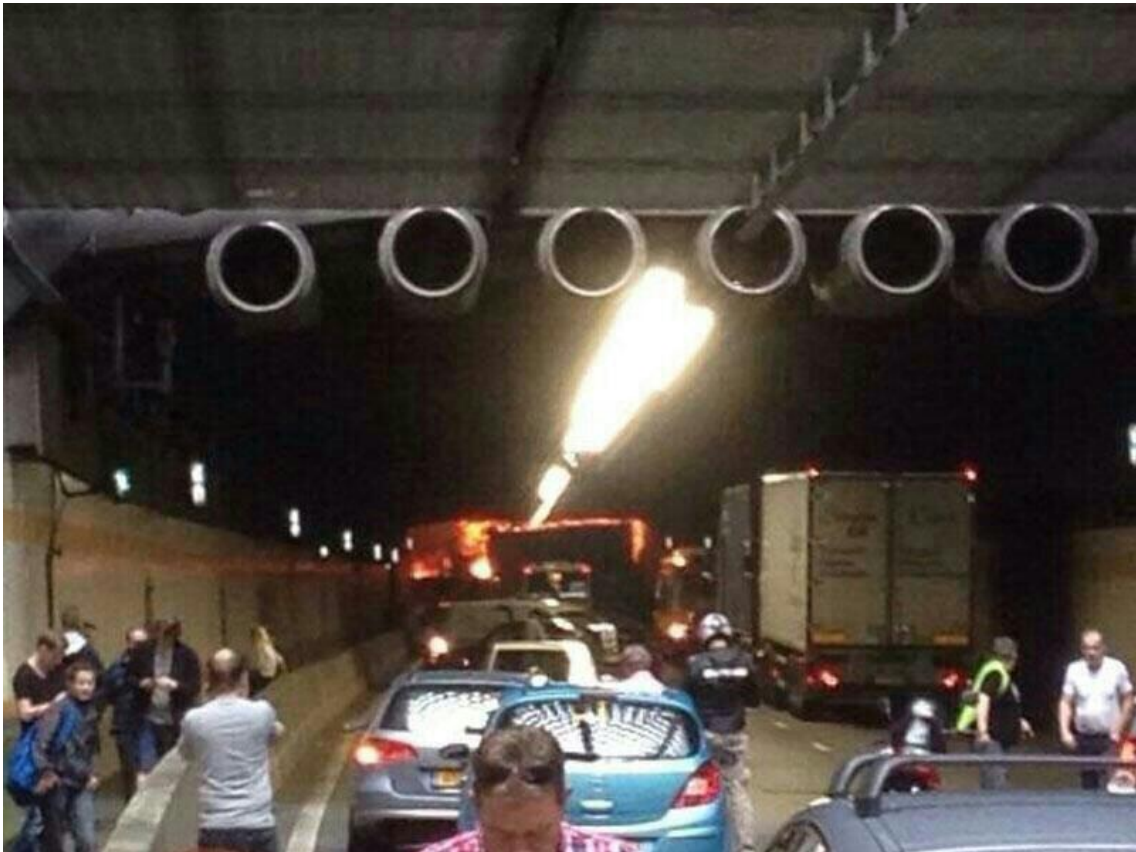
Figure 5 gives an impression of the situation short after the accident. Figure 6 gives an impression of the amount of smoke produced by the fire.

Figure 5 Picture of the fire in the tunnel. (source: Twitter account Richard Hoogeveen, @RichardMaasdijk)

The tunnel roof and the upper parts of the walls are protected with a 27,5 mm thick PROMATECT-H lining. The lining is mounted in 1990. The longitudinal tunnel ventilation system was on during the fire. The picture in figure 5 shows that the part of the tunnel behind the truck is clear of smoke, while flames are visible in the entire tunnel cross section. Smoke is pushed to the tunnel exit on the south side (figure 6). The damage patterns on the

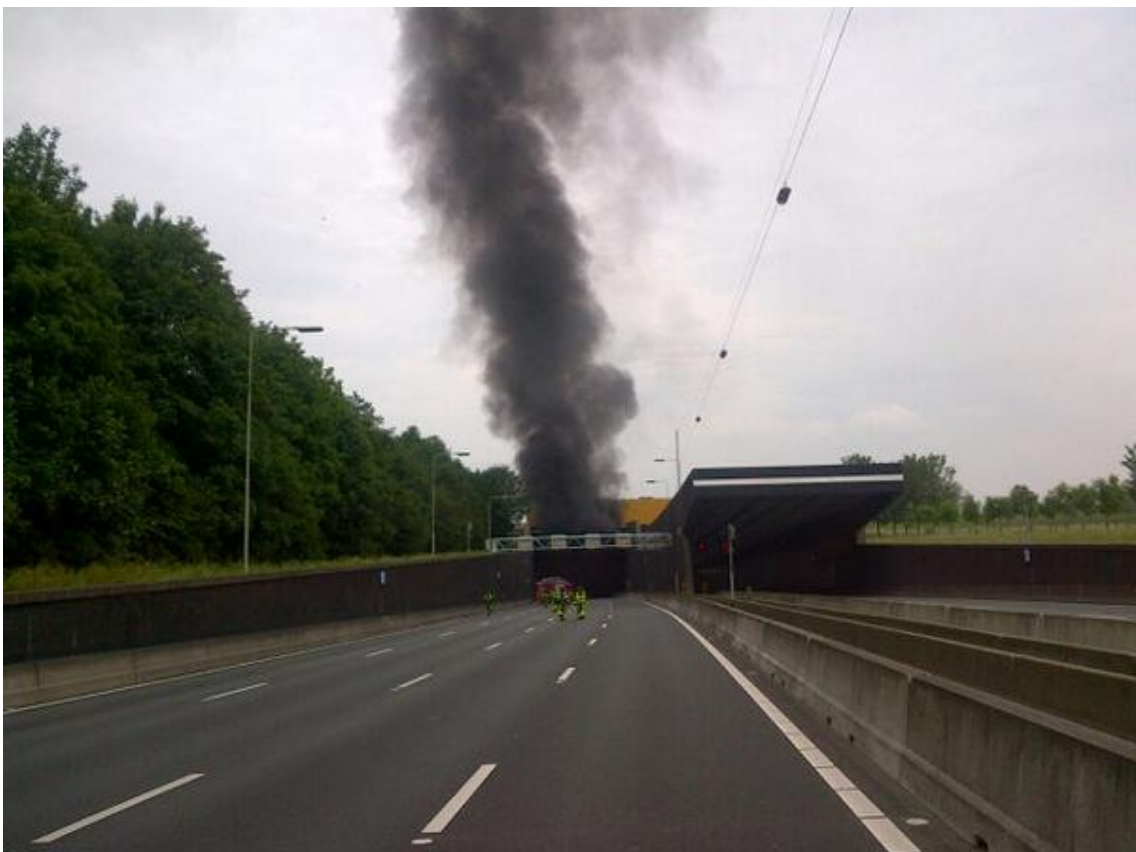
Figure 6 Smoke at the tunnel south exit (source: [www.hulpverleningsforum.nl](http://www.hulpverleningsforum.nl))

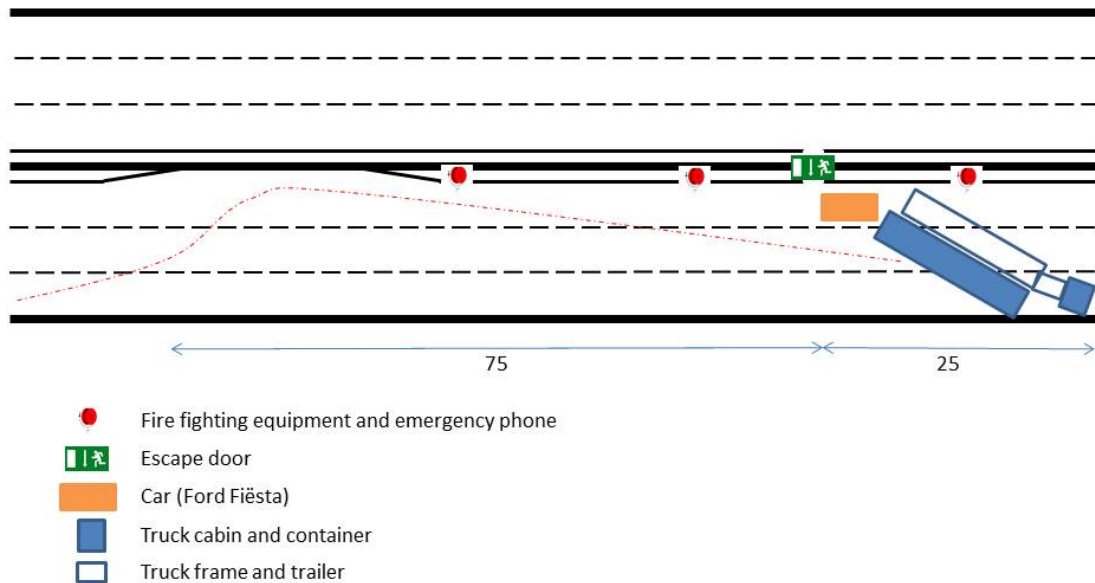
Figure 7 gives an impression of the situation in the tunnel after the accident.

Figure 7 Schematic situation in the tunnel after the accident

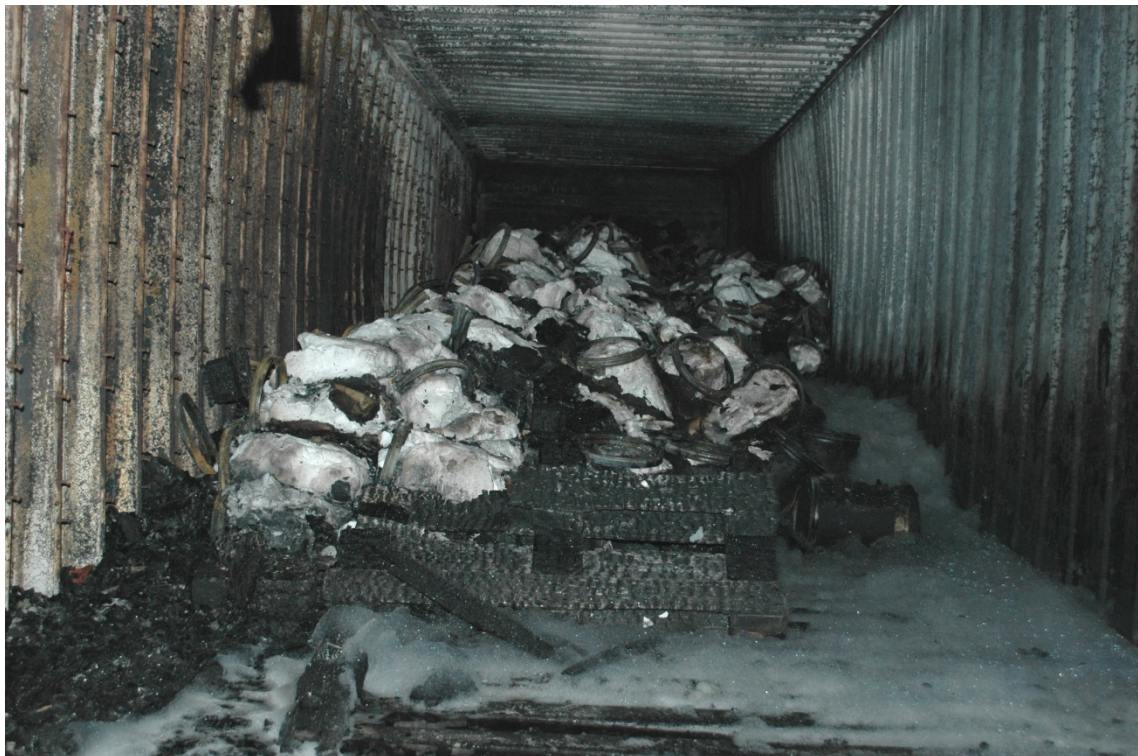
According to the camera images from the tunnel, the fire lasted for about 31 minutes. The cabin of the truck, the container floor, the truck tyres, the (diesel) fuel and the front of the car were consumed by the fire. The cargo load of the truck in the 40'container consisted of drums filled with salt, stacked on wooden pallets. Most of the wooden pallets and the drums were consumed by the fire. The salt was still in the container.

Figure 8 Remains of the truck cargo load.

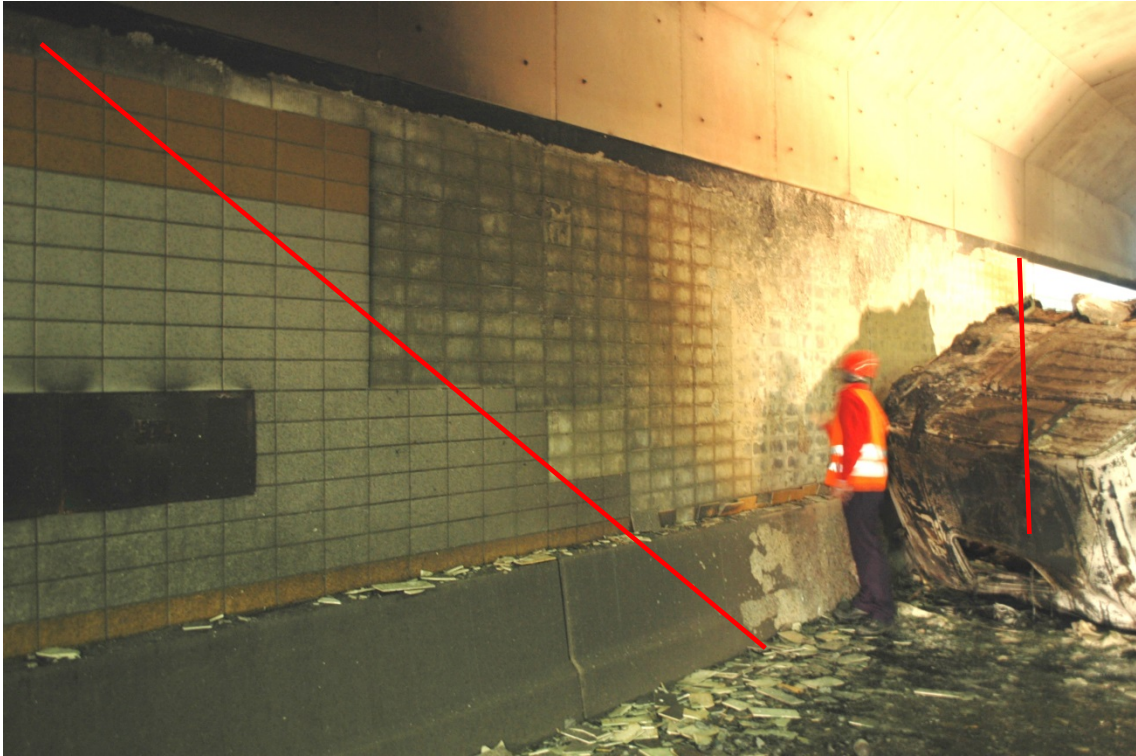
wall next to the truck cabin also indicate the influence of longitudinal ventilation. Figure 9 gives an impression of the damage pattern on the tunnel wall. The damage extends in the direction of the airflow.

Figure 9 Damage pattern on the tunnel wall

The red lines in figure 9 give an indication of the shape of the damage.

An indication of the thickness of the smoke layer in the tunnel during the fire can be found in figure 9. The black rectangle on the left side of the picture is an escape route sign. This sign is totally covered in soot, which indicates that the smoke layer was at least as low as 1,2 meters above the road surface. In figure 11 a sign above a fire extinguisher placed on the tunnel lining is not covered in soot (on the bottom right side of the picture). This gives an indication that there was no or just a thin smoke layer on the up wind side of the truck.

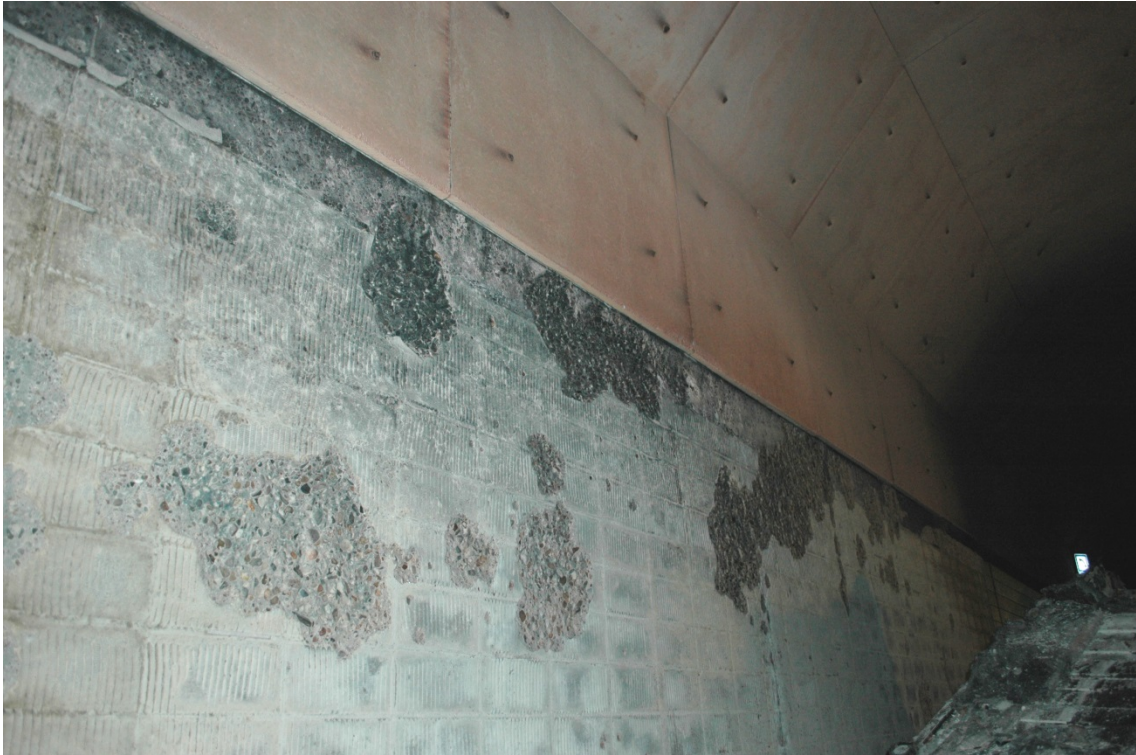
In the direct vicinity of the truck cabin the concrete wall showed damage due to spalling. A maximum spalling depth of 2,5 cm was measured (figure 10). The concrete showed a buff discolouration, which indicates temperatures<sup>10</sup> reached more than 1.000 °C. The discolouration of the concrete was only visible around the cabin and can be explained by direct flame impingement.

Figure 10 Spalling of concrete

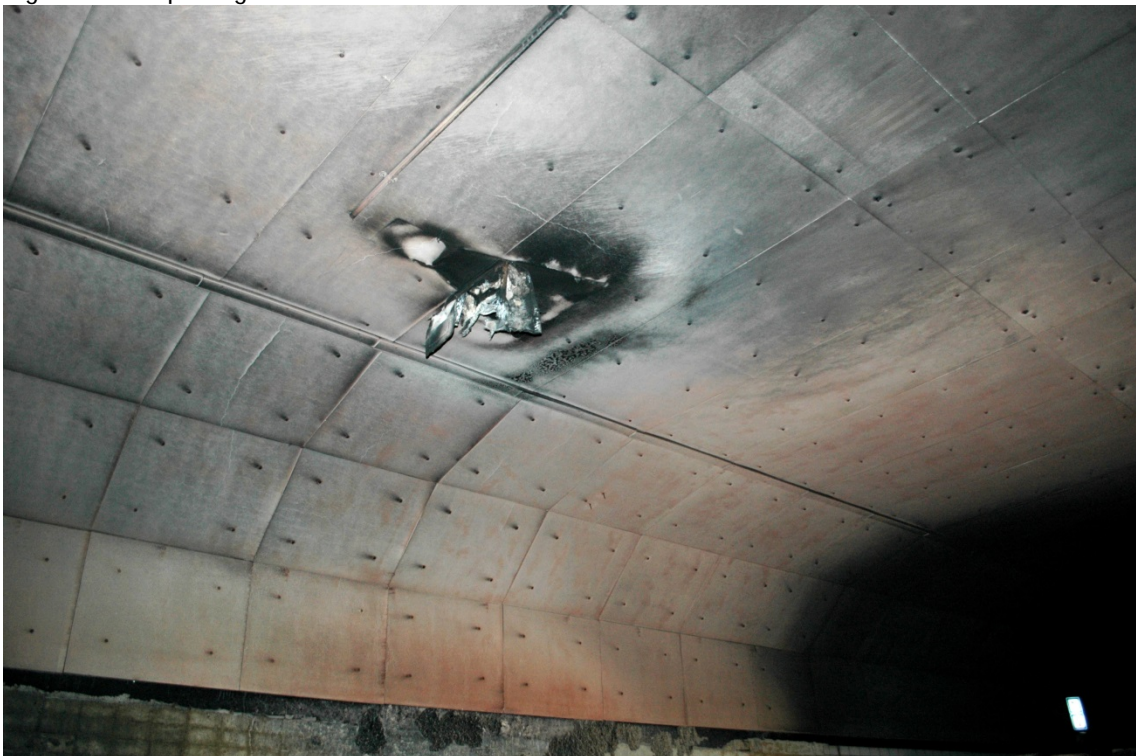
Figure 11 The tunnel lining directly over the cabin shows a clean burn.

Directly over the cabin and in front of the cabin a clean burn pattern was visible on the tunnel lining. The lining has a black appearance along the length of the tunnel (this is probably due to soot from traffic). Due to the fire the black layer of soot directly above the cabin of the truck was burned off.

Figure 11 gives an impression of the lining on the tunnel wall and roof directly over the cabin. In this picture you can see the remains of a speaker of the PA system. The speaker was consumed by the fire.

From within the tunnel the PROMATECT-H lining showed no visible damage. After editing the photo used in figure 11 it became visible that some parts of the tunnel lining were cracked. It is not possible to determine whether these cracks are a result of the fire or were present in the lining before the fire occurred.

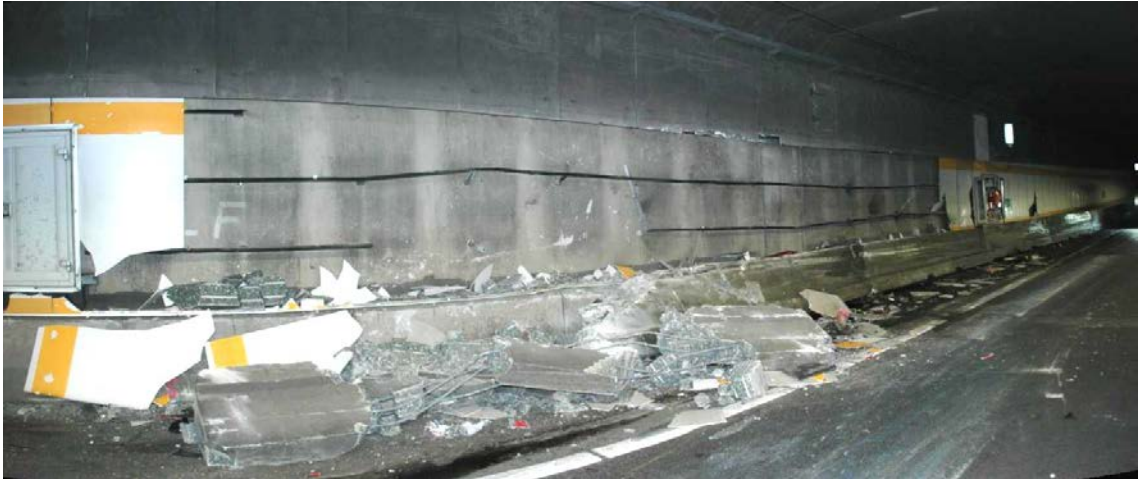
In figure 12 the damage to the barrier and the left tunnel wall due to the crash is visible.

Figure 12 Damage to the barrier and the left tunnel wall due to the crash

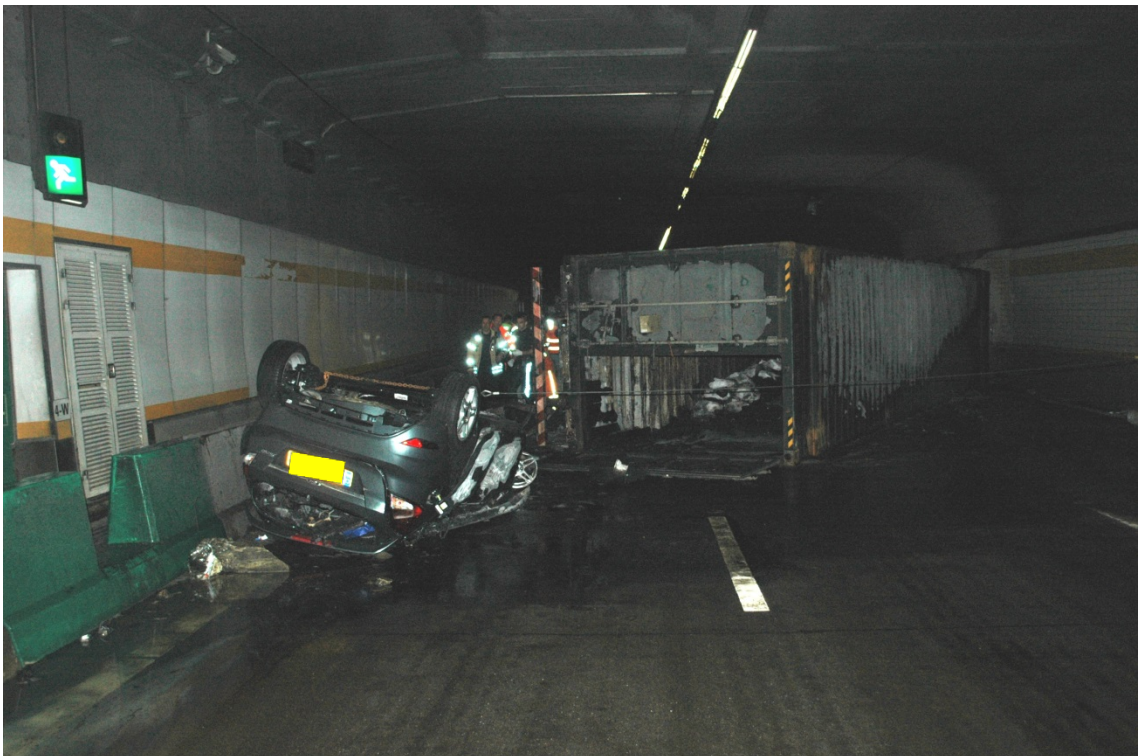
On the tunnel roof a lighting system was installed consisting of LED lights. Most part of this lighting system was still working after the fire. Some parts were melted or sooted. In figures 13 and 14 the damage to the lighting system is visible in an overview of the accident area in the tunnel.

Figure 13 Overview from behind the truck. Large parts of the lighting system are on after the fire

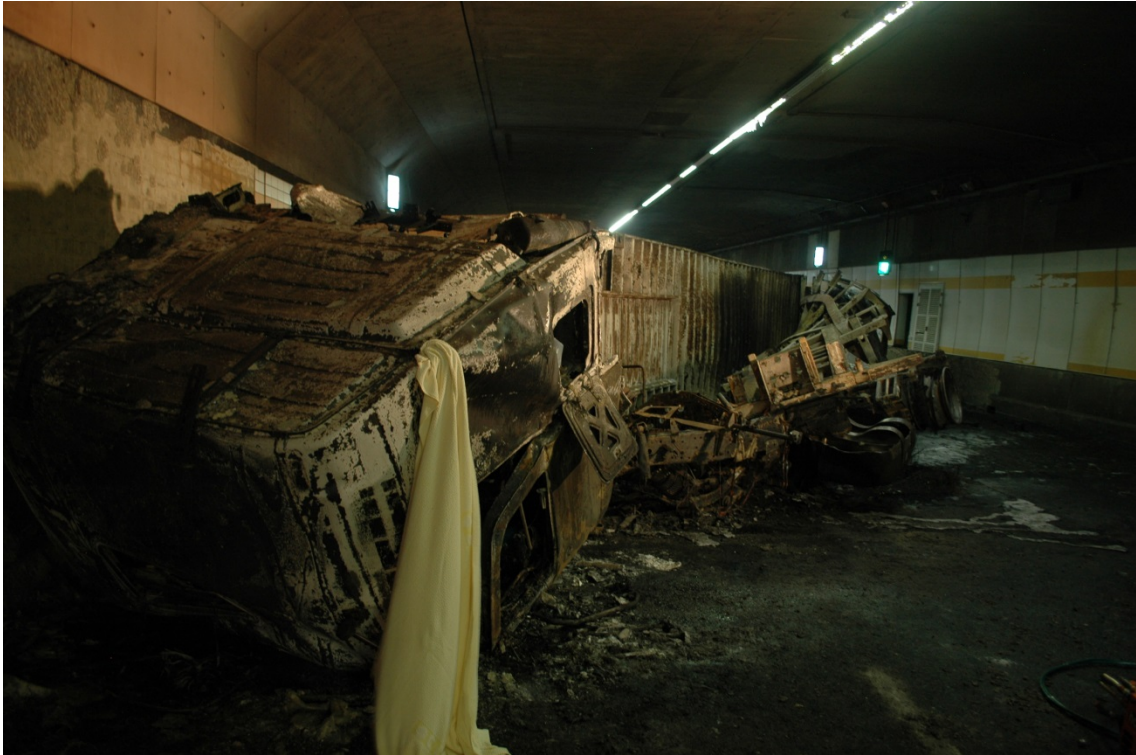
Figure 14 Overview from the front side of the truck

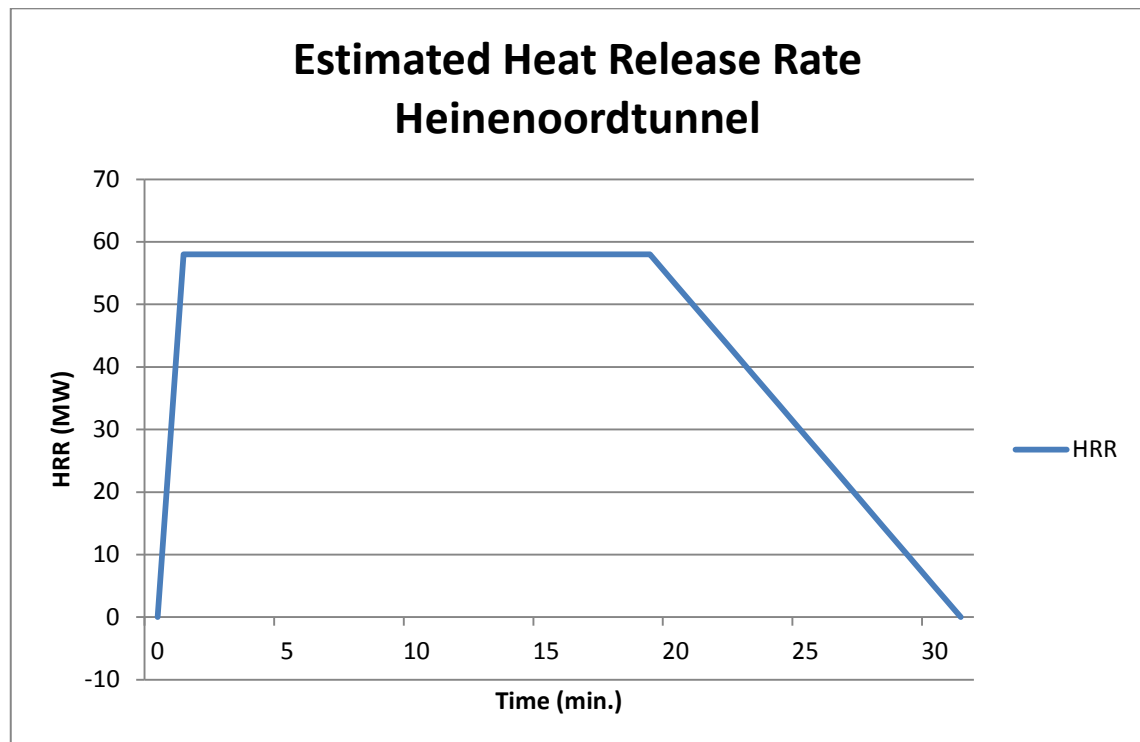
The previous analysis leads to a fire curve that grows to a maximum in 1 minute and maintains about the same rate of heat release (HRR) during 18 minutes. The fire lasted for a total of 31 minutes.

The peak output of the fire is estimated to be between 50 and 65 MW. In figure 15 the estimated fire curve is given.

Figure 15 Estimated fire curve
