Efectis Nederland report

Investigation of fire in the Lloydstraat car park,

2007-Efectis-R0894(E)

Rotterdam

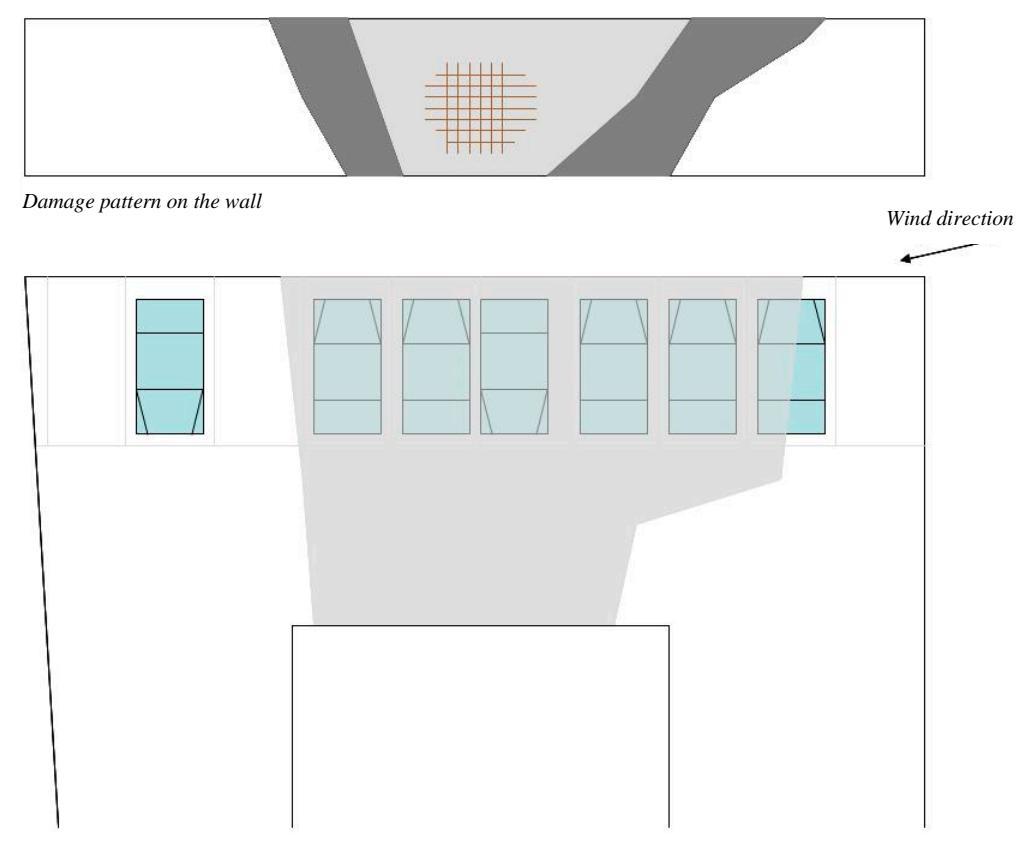
Figure 5: Damage patterns

Damage pattern on the ceiling (only visible damage on the concrete!)

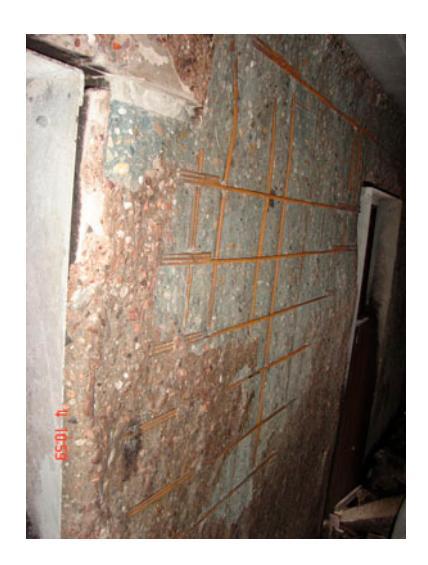
The temperatures that arose during the fire cannot be determined accurately. On the basis of the discolouration of the façade, such as that shown in Figure 10, it can be deduced that the temperature at the façade was probably not higher that 1000° C.

Figure 10: Discolouration and spalling of the concrete

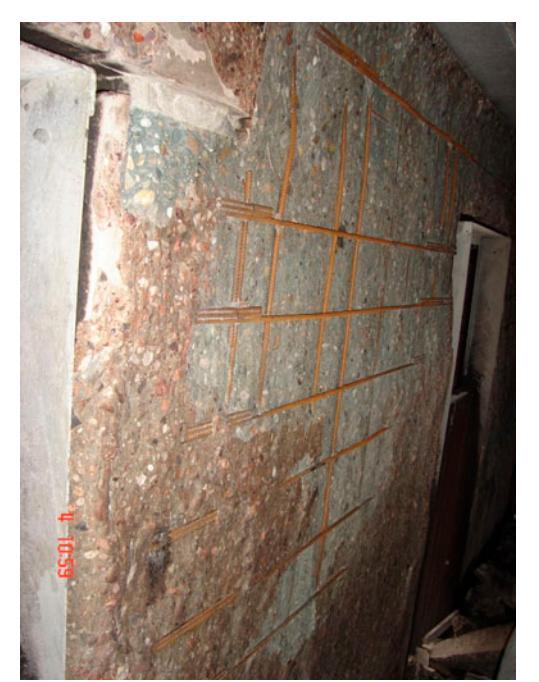
The interior of the load bearing prefab façade elements has undergone spalling to a depth beyond the steel reinforcement. Because of this an eccentric load exists whereby the façade is inclined to buckle towards the outside. The buckling to the outside is held back by the floor (as far as the floor is still present). If the façade were to buckle global collapse of the floors above is likely.

Figure 13: View of the spalled concrete surface of the façade.

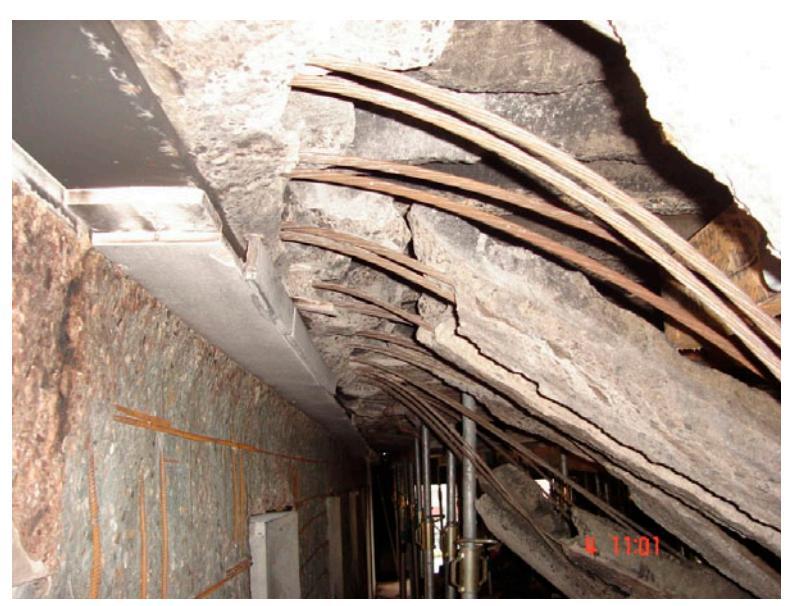
The bottom flanges of the THQ beams and the L-shapes were protected from fire by fire resistant boards. During the inspection of the fire damage this protection was to the greater part still intact. Probably the temperature of the steel remained limited due to the fire protection. Had the steel temperature become too high then the bottom flange could have deformed, possibly causing the hollow core slabs to slide off their supports.

Figure 15: Steel L-shape is still intact, and the fire protection is partially present after cooling down.

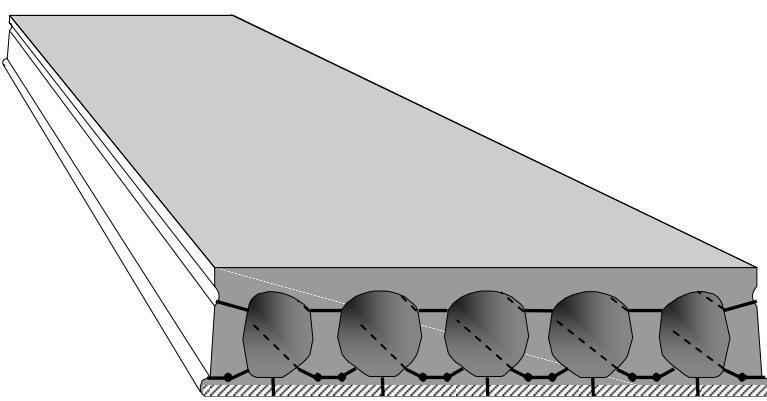
Large cracks occurred in the slabs, in many cases causing large parts of the slabs to fall down. The figure below schematically shows the shape of the cracks.

Figure 16: Schematic cross-section of the damage in one of the hollow core slabs. The black lines represent cracks and the hatched area is the spalled concrete.

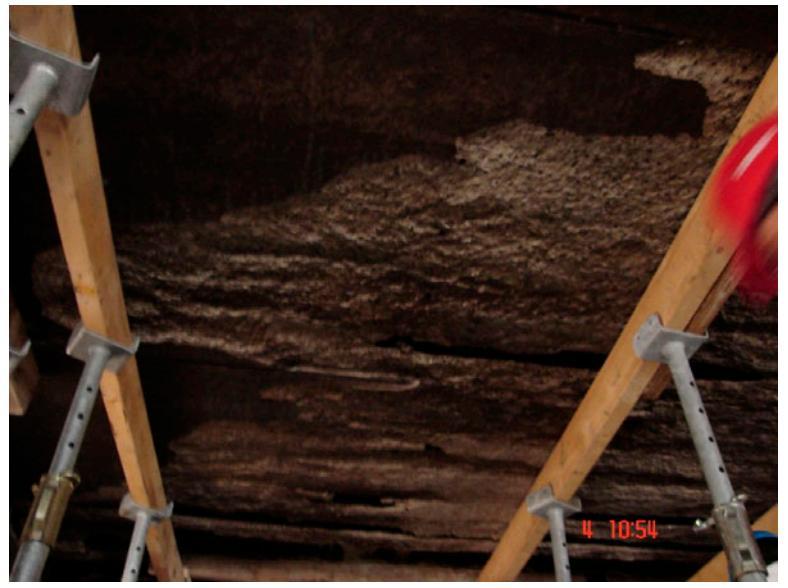
Figure 17: Spalled underside of the hollow core slab (slightly further away from the fire). The picture shows that the spalling reaches the hollow cores in many places.

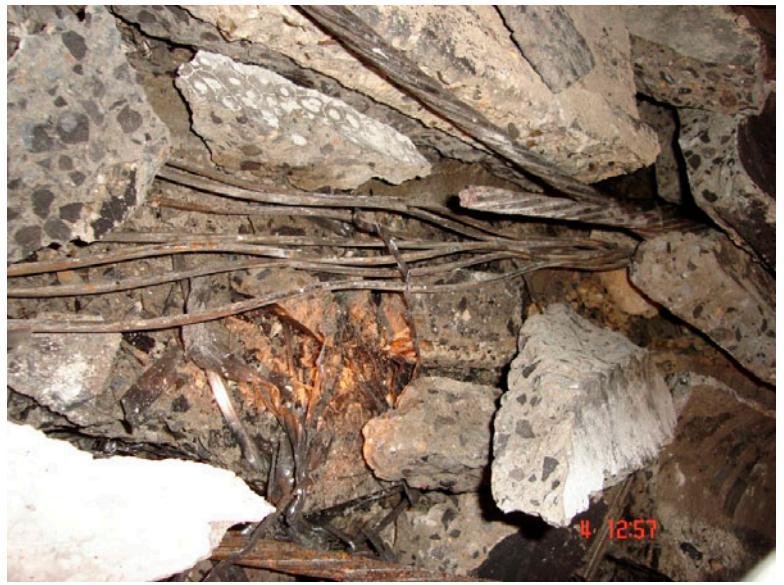
Figure 18: Some strands were completely twisted apart from each other because they were forced out of the concrete during the collapse of the bottom part of the floor. Most of the strands were not twisted apart from each other because the concrete cracked around the strand.

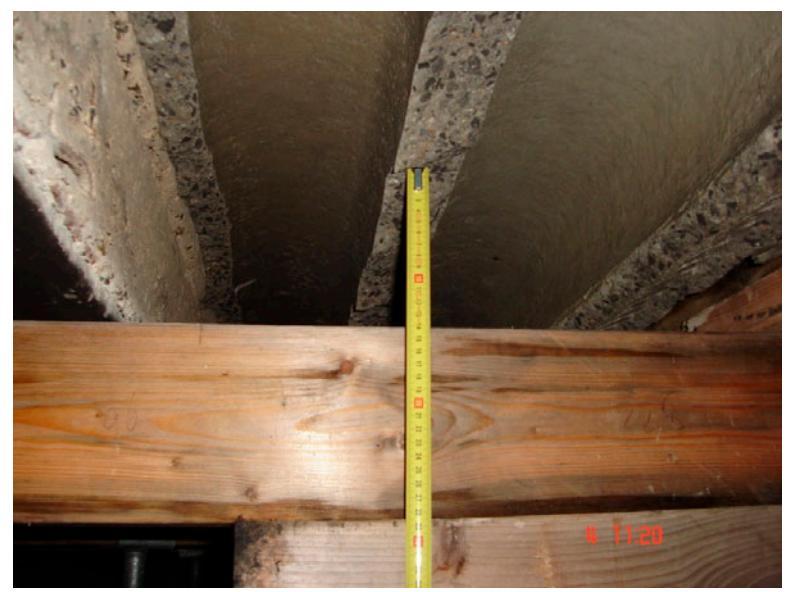
Figure 19: The crack is at a distance of approximately 14cm from what was the underside of the slab.

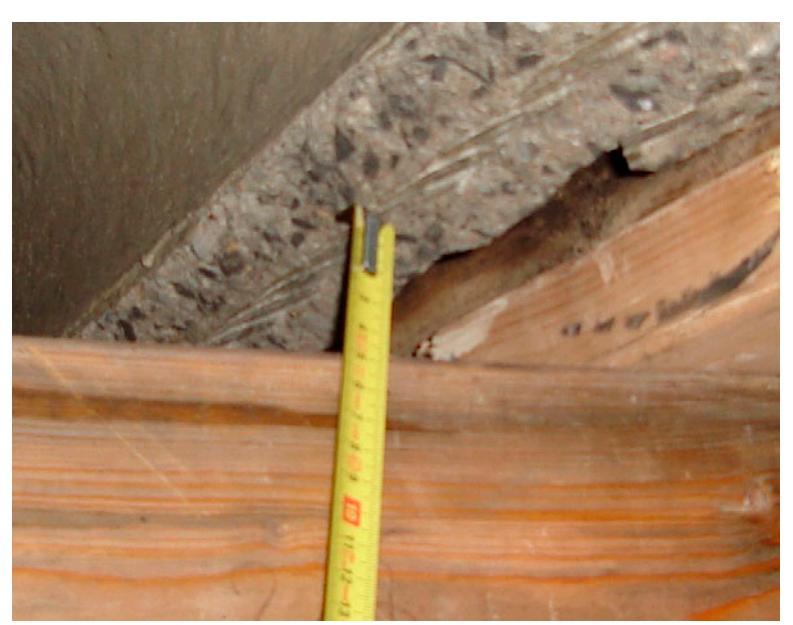
Figure 20: The upper side of the strand lay at about 5cm from what was the underside of the floor slab, so the concrete cover was about 4cm.

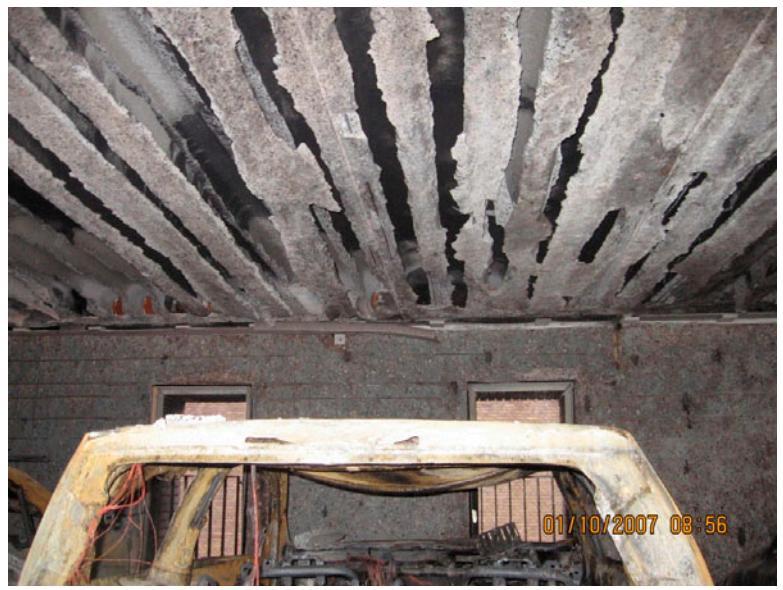
Figure 21: Concrete spalled to the depth of the hollow cores, but the pre-stressing strands are still covered. (picture: Rotterdam Local Building Authorities)

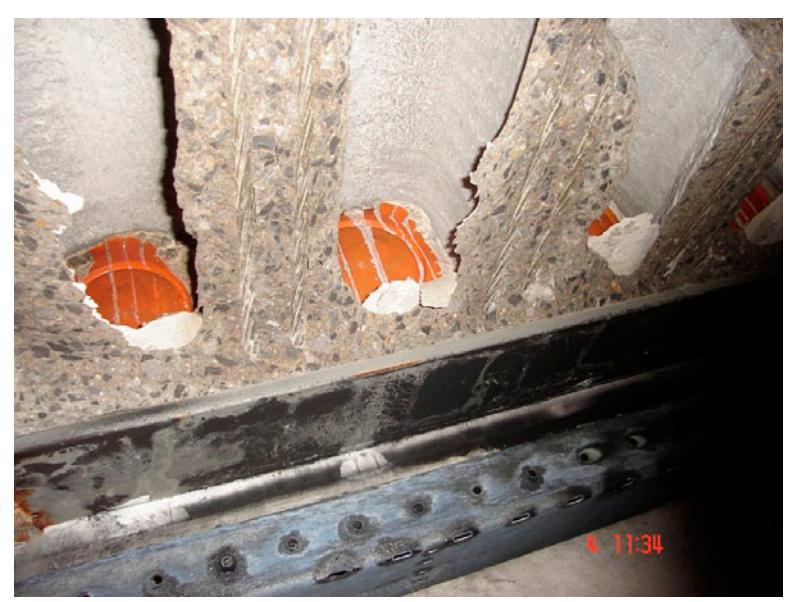
Figure 22: Crack in the plane of the pre-stressing strands, picture taken close to the support.

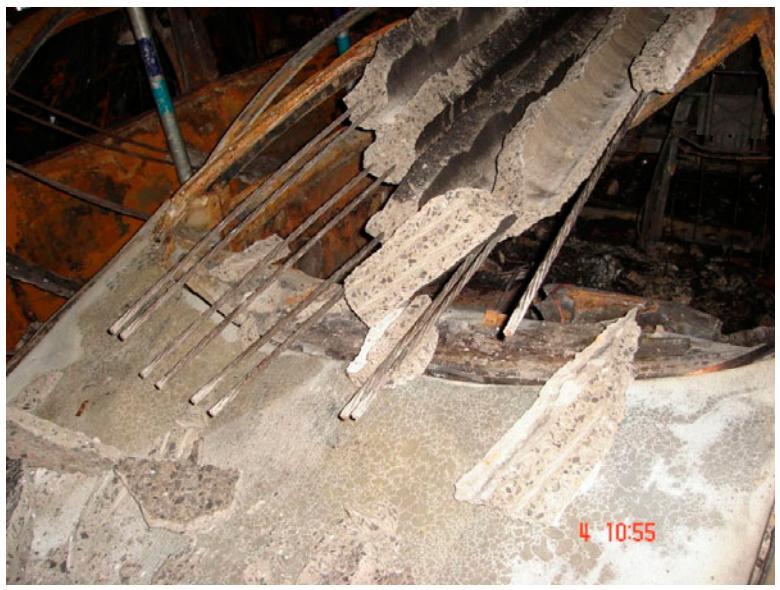
Figure 23: The crack causes the strands to be released. In some cases the strands are fully extracted from the concrete, causing the bottom half of the slab to fall down on a car.

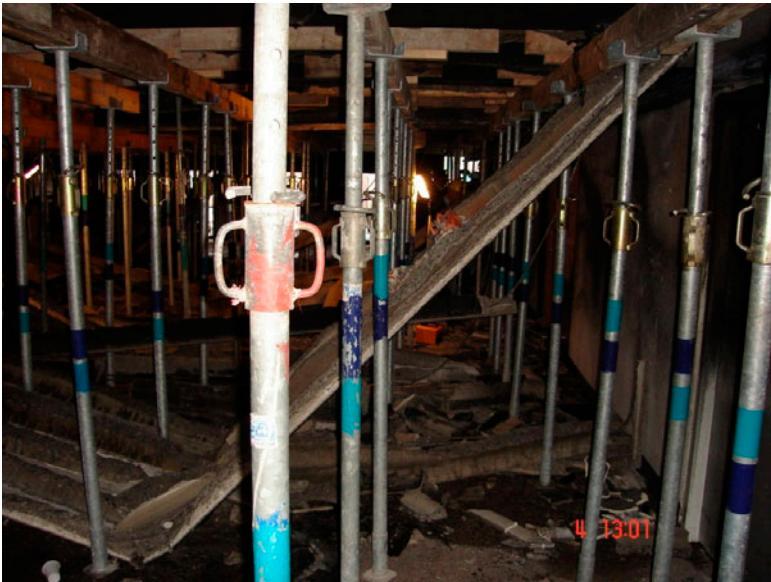
Figure 24: Fallen bottom half of the floor slab on the other end of the span. In the right hand side top corner of the picture, the strands are still connected to the concrete above the support.

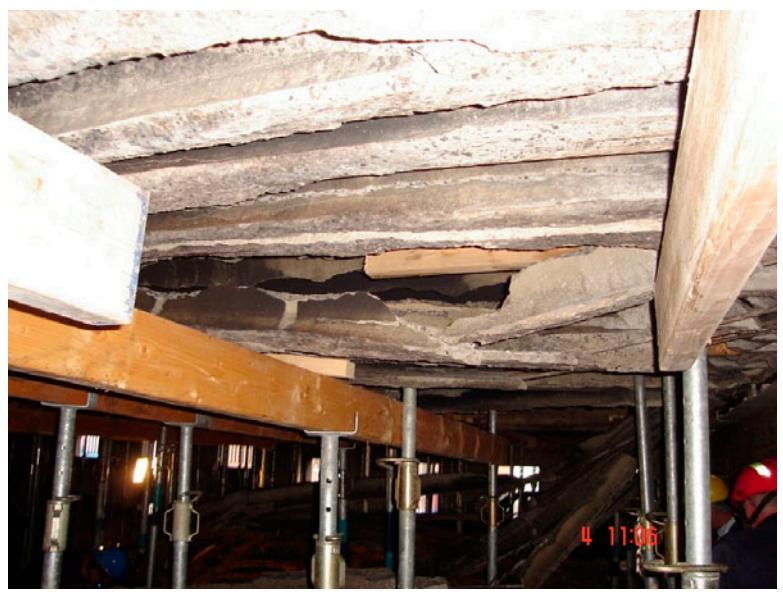
Figure 25: In some cases the bottom half of the slab remained hanging because both ends of the pre-stressing strands still were fixed in the concrete above the supports.

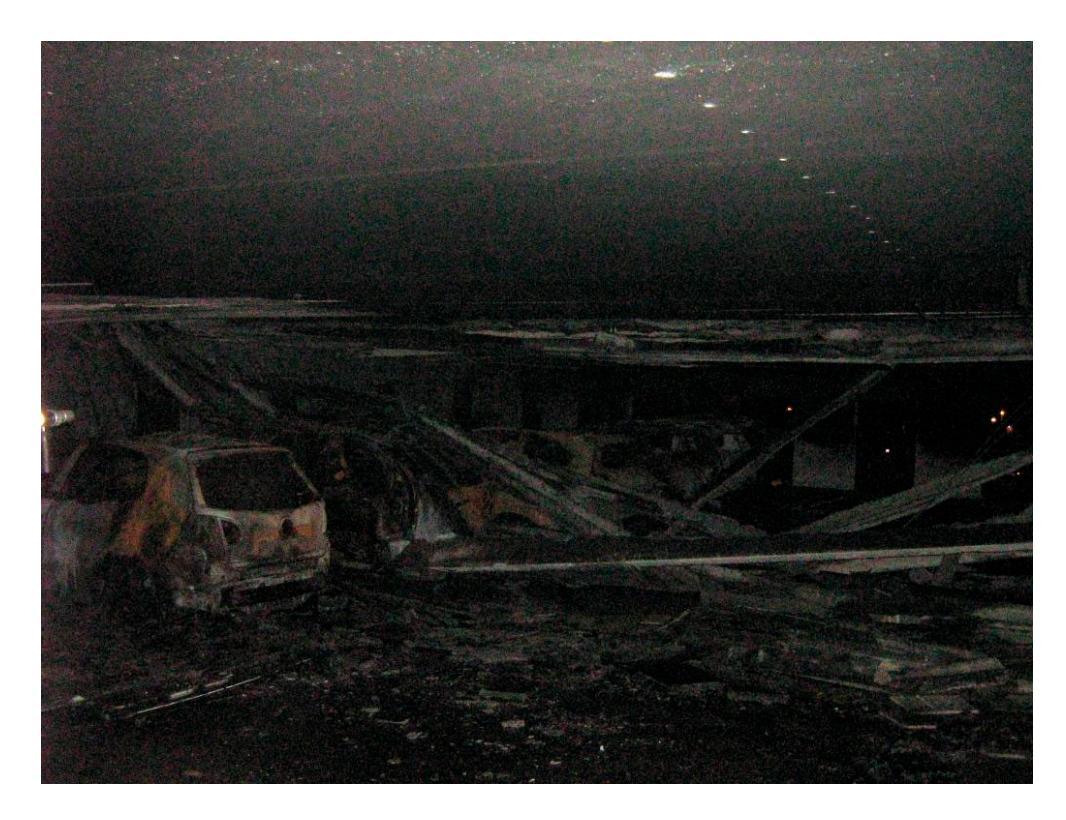
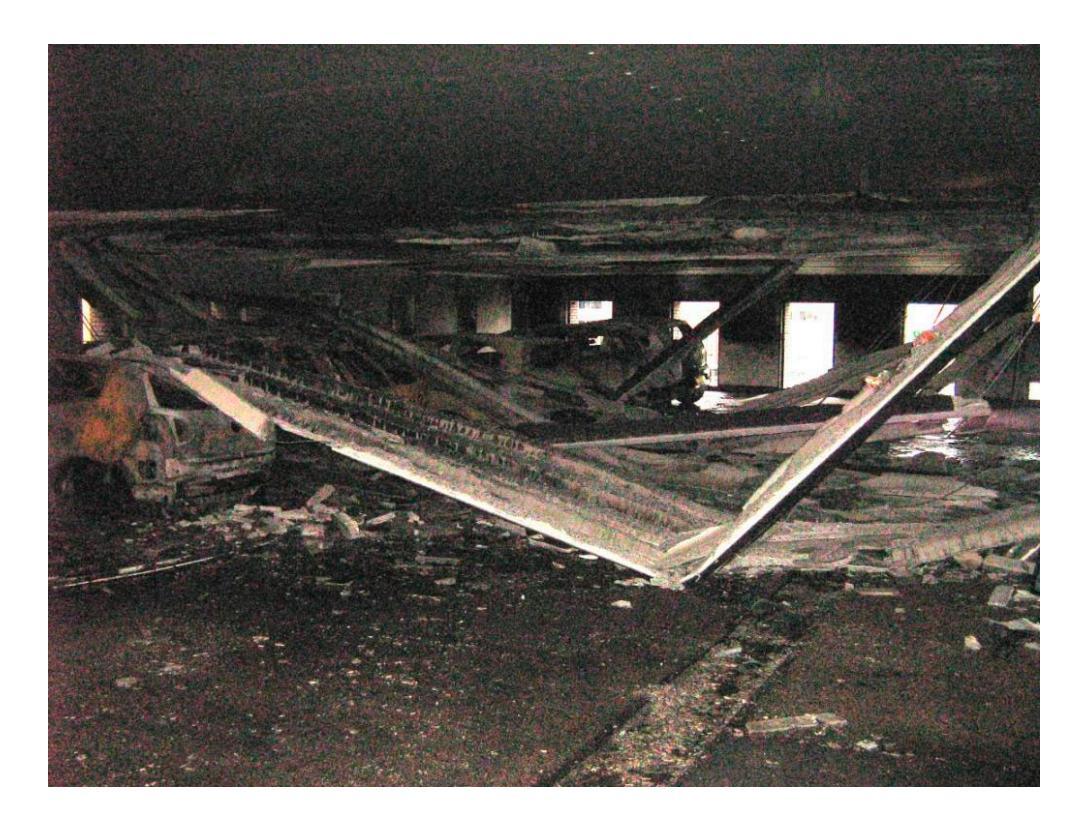
Even so, it appears that the process of crack formation in the hollow core slabs continued during the cooling phase, since certain parts of the floor slabs only fell down a few hours after extinguishing, see figures 28 and 29. This could be due to the fact that the heat further penetrated the structure. While the surface of the structure is already beginning to cool some of the heat that is already present in the structure will conduct further into the structure.
