Efectis Nederland report

Investigation of fire in the Lloydstraat car park,

2007-Efectis-R0894(E)

Rotterdam

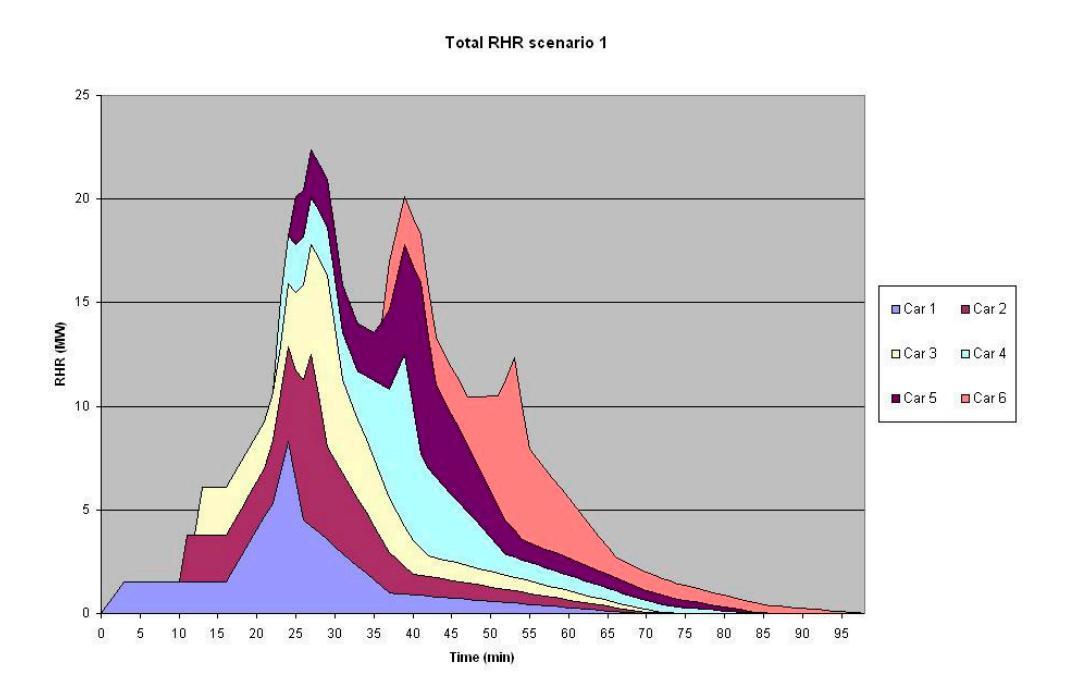
Figure 8:Total rate of heat release scenario 1

Figure 8 and 9 show the total heat release that can be produced during the fire according to scenario 1 and scenario 2 respectively. The heat is not released in one place, but is spread over the compartment.

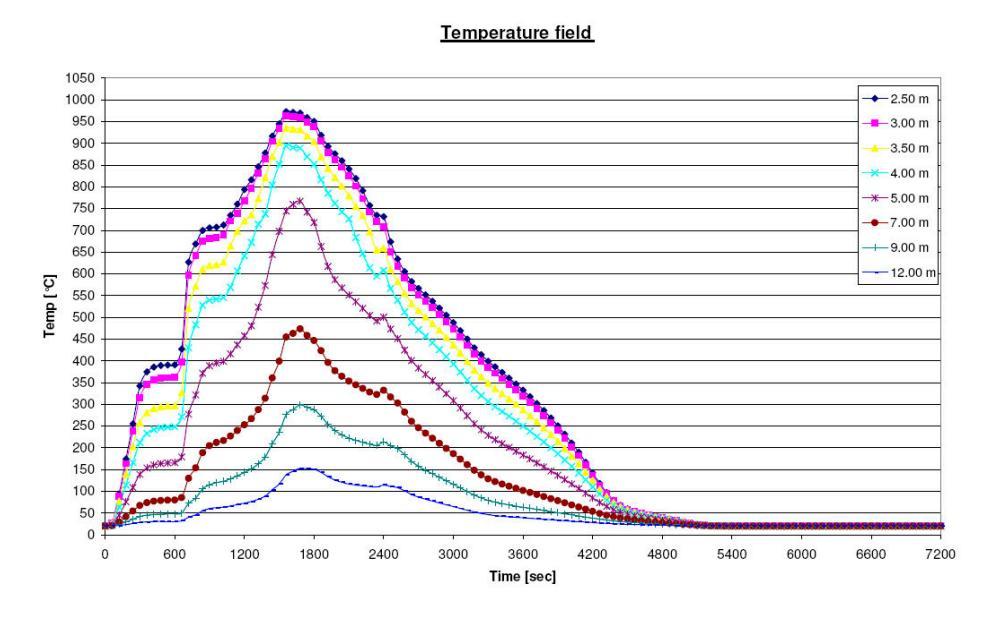
Figure 11: Temperature development scenario 1

Using the numerical model CaPaFi version 2.0 (Car Park Fire) from DIFISEK the temperature development has been determined for the two previously described fire scenarios. Figure 11 shows the temperature development for scenario 1 and Figure 12 gives the temperature development for scenario 2. It is noticeable that the difference in temperature is only a few degrees. In the diagrams the temperature at the ceiling (2.4m high) is given in relation to time and distance from the fire.

The graphs for both scenarios are almost identical to the standard fire curve from 0 to 1000 seconds. From 1000 to 2000 seconds the temperatures are higher. After 2000 seconds the modelled temperatures are lower than the standard fire curve.

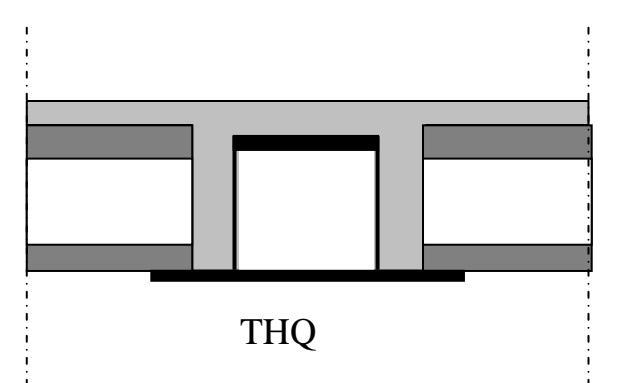
Figure 14: Schematic cross-section THQ beam. This is a rectangular hollow section with a plate that juts out from both sides. The hollow core slab is laid on the protruding plate, the gap between the end of the hollow core slab and the side of the THQ beam is filled with concrete.

The bottom flanges of the THQ beams and the L-shapes were protected from fire by fire resistant boards. During the inspection of the fire damage this protection was to the greater part still intact. Probably the temperature of the steel remained limited due to the fire protection. Had the steel temperature become too high then the bottom flange could have deformed, possibly causing the hollow core slabs to slide off their supports.

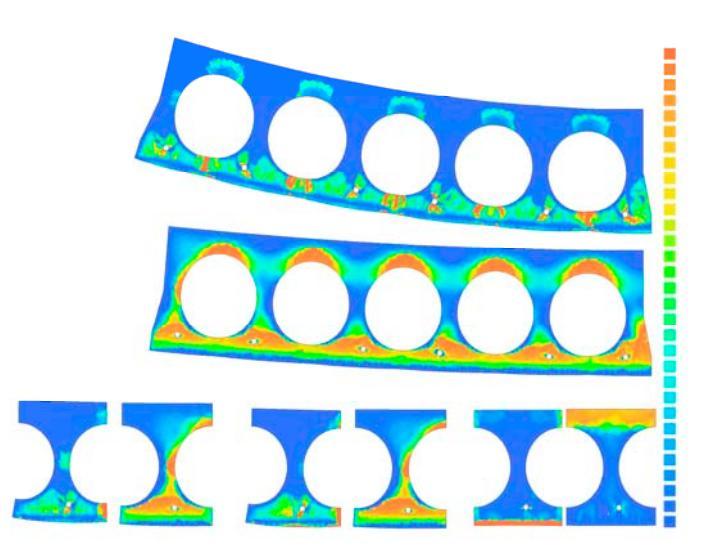
The most relevant is the recently internationally published work of Dr. J.H.H. Fellinger. In his doctoral research⁷ he investigated the collapse of hollow core slabs on shear and on anchorage of the strands. Crack formation comparable to the damage observed in the building on Lloydstraat has also been theoretically determined by him for a similar type of floor. However, this was not a main goal of the research. He attributes this cracking to laterally restrained deformation. At the end of his thesis he writes: "further research is recommended into (..) the effects of transverse restraint on the horizontal cracks at mid depth in the (..) slab."

Figure 26: Calculation of cracking in the cross-section of a comparable hollow core slab (source: Fellinger 2004)

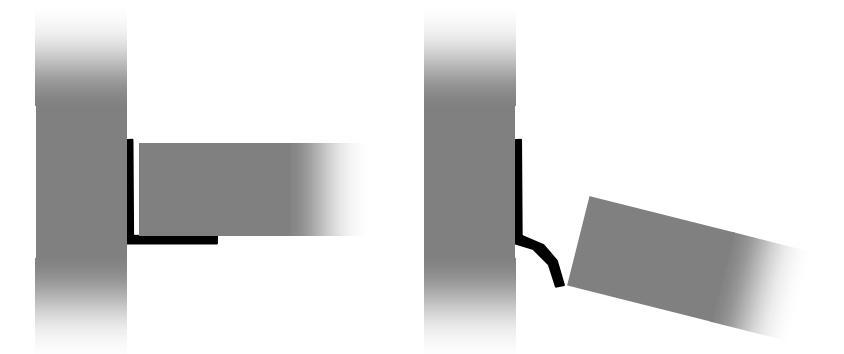
The steel elements (L-shape and THQ beams) upon which the hollow core slabs were placed, were protected with fire resistant boards of thickness 12 to 15mm. Efectis did not check whether this thickness is sufficient for the required fire resistance. The fire resistant boards did in any case ensure that the steel elements were not severely deformed. Because of this the hollow core slabs did not fall from their supports. Without the fire resistant boarding it is quite conceivable that this would have occurred.

Figure 27: Collapse of the floor due to deformation of the bottom flange of the L-shape (not observed in the investigation under consideration here).
